TROUBLE SHOOTING LOGIC BOARD PART II

MIDWAY MFG. CO.
A BALLY COMPANY
10750 WEST GRAND AVENUE
FRANKLIN PARK, ILLINOIS 60131
U.S.A.

Galaxian

TABLE OF CONTENTS

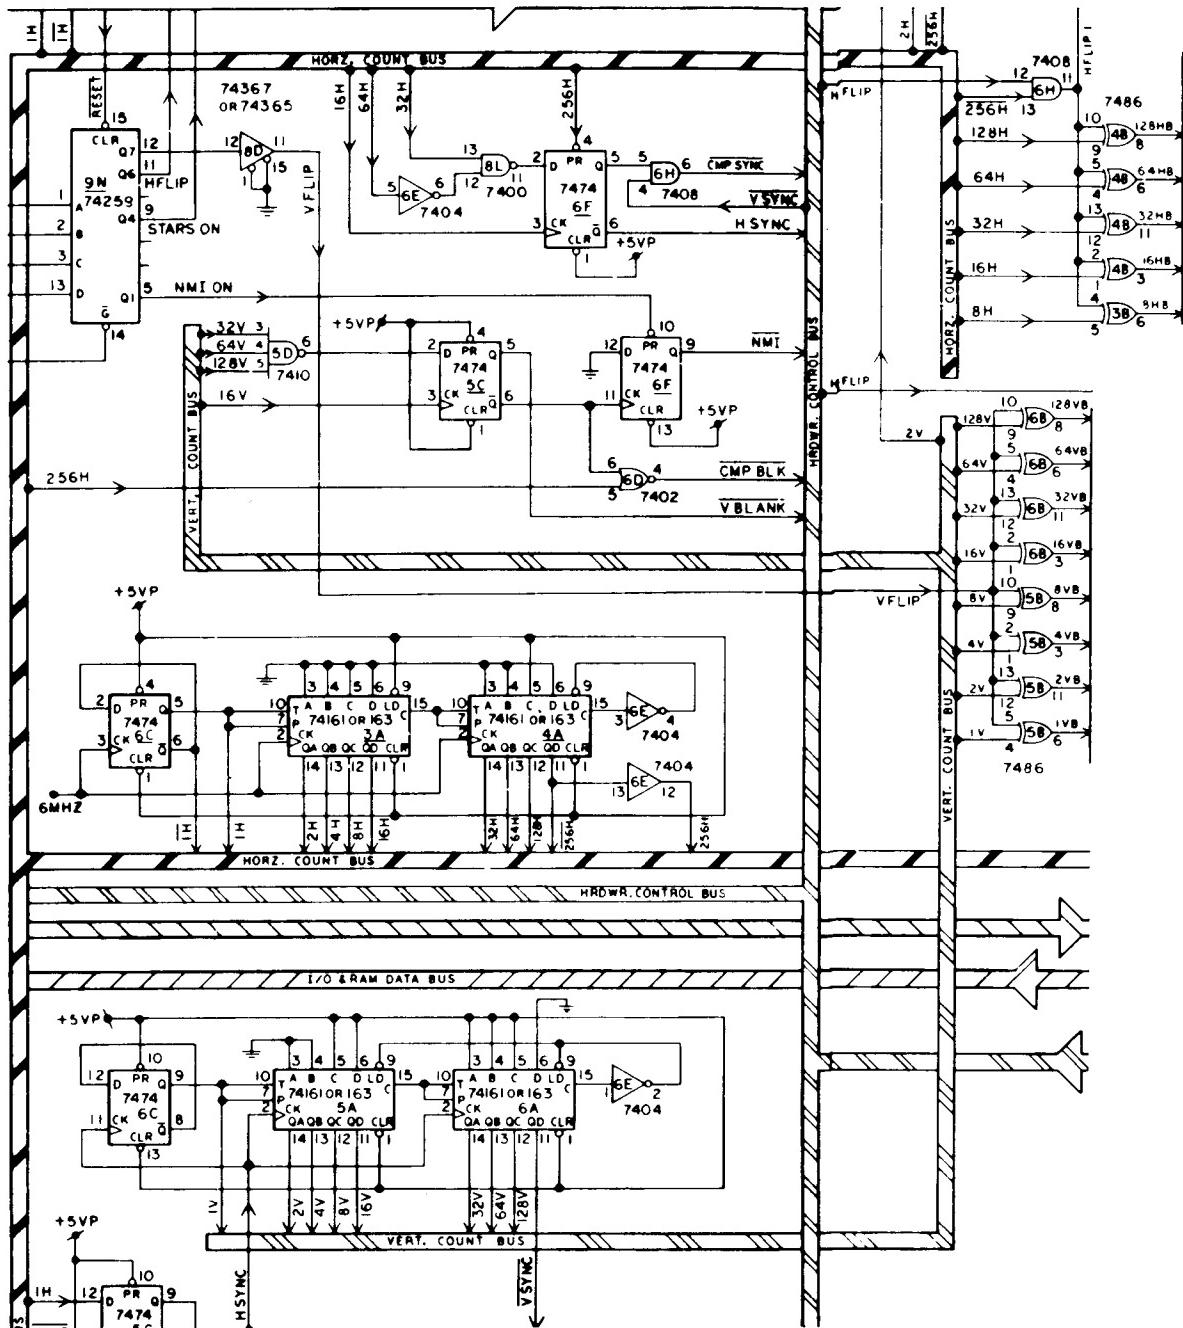
FIG.1. SECTION SHOWING 1C 74161s & 7486s

If these chips are found to be OK, the next step is to check the Xor gates located at 3B, 4B, 5B, and 6B. This is done in the same manner as the 74LS161's just discussed. Figure 1 shows the entire section with the Xor gates on the outputs. The inputs of these chips should resemble the outputs. If they do not, cut the pin and check the line and the pin. If the pin is OK, reconnect the first pin cut, then cut any pin connected to that line until the line looks right again. Replace faulty part.

If the lines do not appear on any of the output pins on 3A,4A,5A, & 6A cut the pin and check with Video Probe. The lines will appear if the 74LS161 is good. If the lines are missing change the 74LS161.

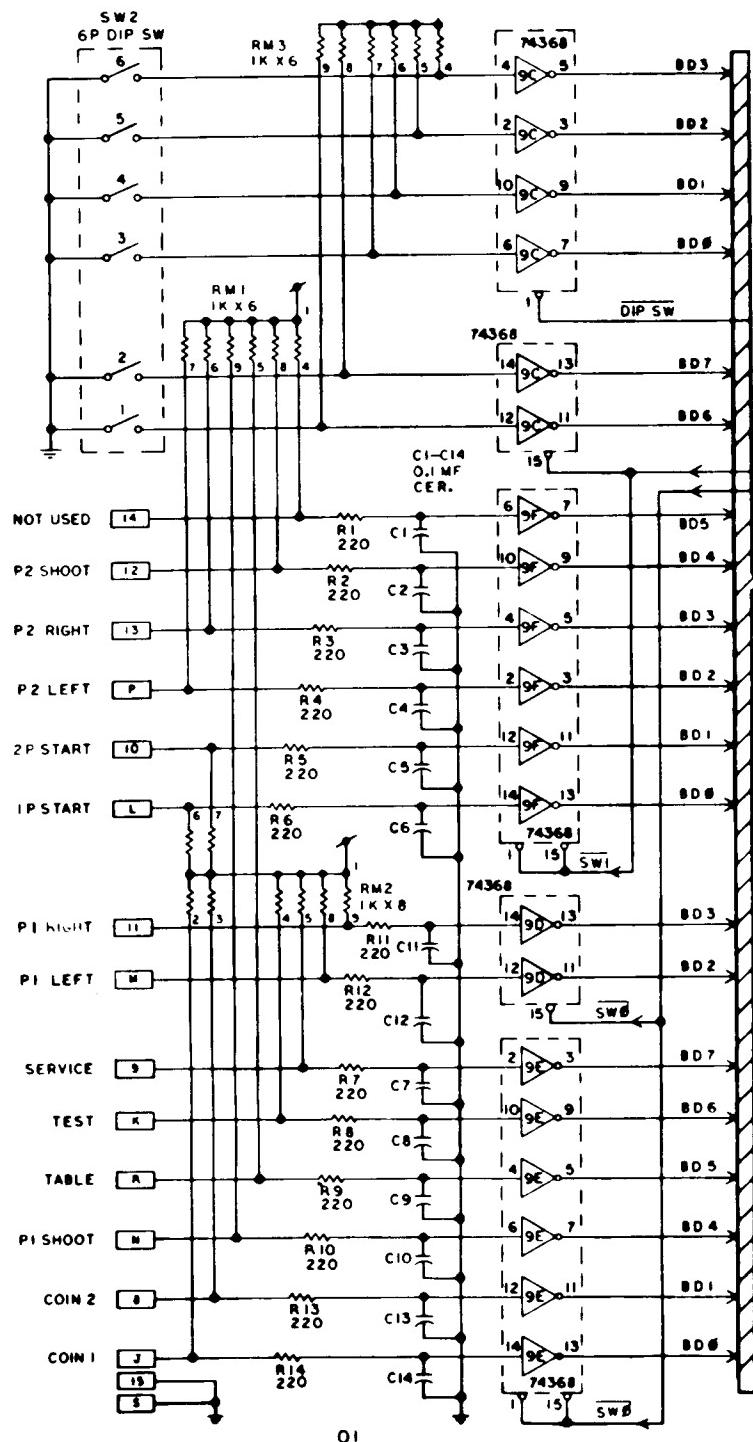
FIG. #2 SECTION SHOWING 74368s

If any switches (left, right, fire, etc.) fail to work or emit a game noise during test mode, procede as follows:

- 1) Clean contacts on faulty switch with a stiff pen eraser.
- 2) With an ohm meter, check the wire from the switch to the game board for continuity.
- 3) Check the corresponding resistor and .1uf capacitor for proper value.
- 4) If the capacitor proves to be faulty, replace it.
- 5) If there is no problem here, change the corresponding 74LS368, according to Fig. 2.

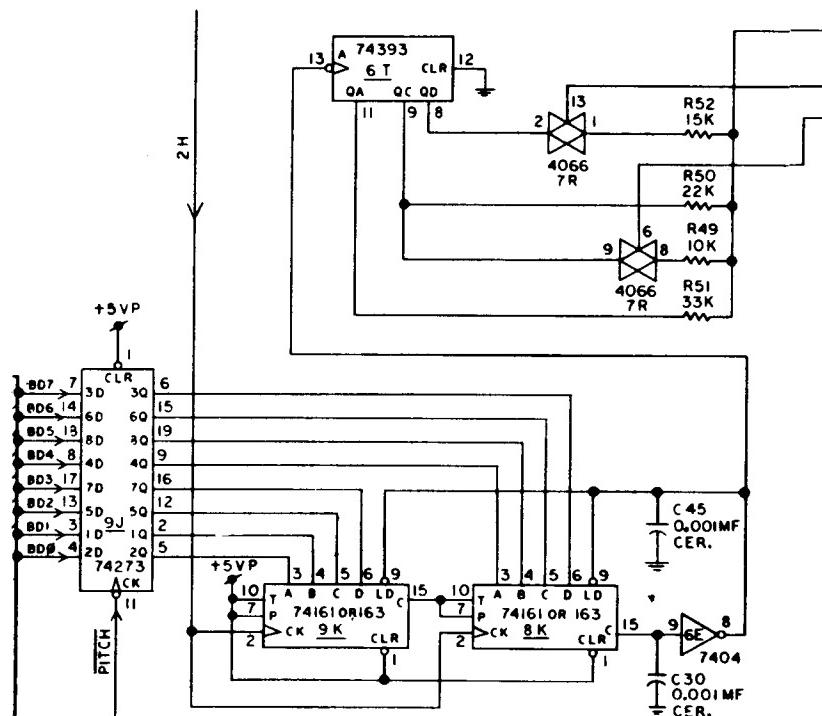
FIG. #3 SECTION SHOWING 74161s, 74393 & 74273

All other sounds are generated by the IC74LS273 at 9J, the two IC74LS161's at 8K and 9K, and the IC74LS393 at 6T as seen in figure 3. Most often these will be indicated if the sounds are "jumbled." There may be a "hissing" noise in the sound which is usually remedied by changing the 470uf capacitor, C37, next to the power supply.

If any one output does not flash, cut the pin and check the pin and the line. If the pin produces a flashing box, change the corresponding IC74LS161. If not, 9J is bad and should be replaced.

Only one output is used from the IC74LS161's, eg pin 15. If nothing is flashing on pin 15 of 8K, check pin 15 of 9K and replace 9K if found to be faulty. When all is normal up to pin 8 of 6E, and the sound is still not good, check pins 6 and 13 of 7R. When normal, pin 6 should slightly dimm the color when using the video probe. Pin 13 should put a solid green block on the screen for the duration of the sound, then dim the color. If this is not the case, cut the pin and check the line. If found to be OK, check the pin on the IC74LS259 at 9L. If the pin on 9L is OK, replace the bad 4066 at 7R. If the pin is bad, replace the bad IC74LS259 at 9L.

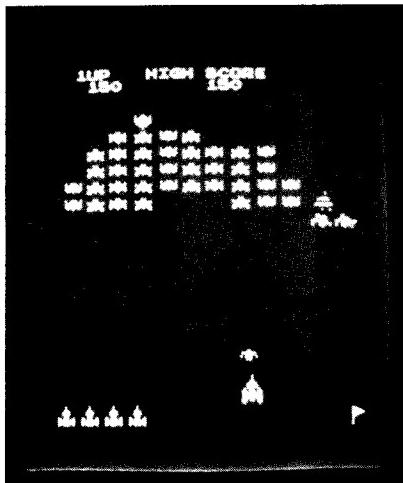
Fig. 17 Missing address on attack Ram. Note - the lines and distortion on divers.
(27LS00)

Figure 17 shows what usually happens when an attack Ram goes bad. When the aliens dive, there may be colored or just black lines through the attackers. When lines appear, it is a symptom of a missing address line within the Ram. Therefore, the bad line may not appear to be bad when viewed with the video probe.

- 1) Connect jumper cable to +5v.
- 2) Touch Pin 6 of each attack Ram and watch divers.
- 3) You will notice one attacker disappears or all attackers look distorted.
- 4) Whichever Ram makes the lines go away when touched to +5v is the defective Ram.
- 5) If socketed, double check by pulling out suspected Ram.
- 6) Replace if found to be faulty.

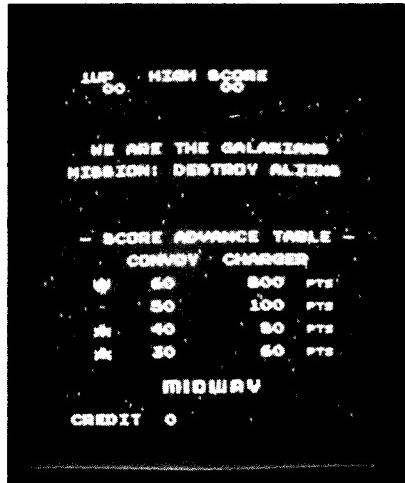
Fig. 18 Bad attack Ram 1S.

Figures 18 and 19 also show symptoms of a bad attack Ram. They also show what happens when the technique listed above is used for 2 of the attack Rams. See No. 3 Above.

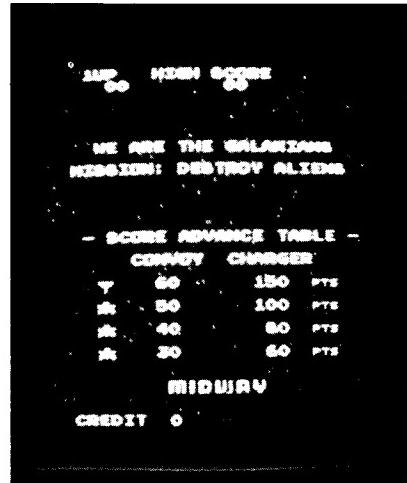
Fig. 19 Bad attack Ram 1R.

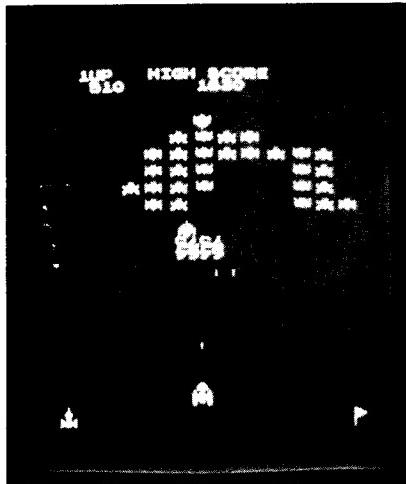
Figure 20 shows a typical reaction to a bad output from IC4L, a 74LS273. When the attackers dive, they may turn into many different and definitely wrong characters such as parts of an explosion, red Galaxip or numbers and letters as shown here.

Fig. 20 Typical of bad output on IC4L.

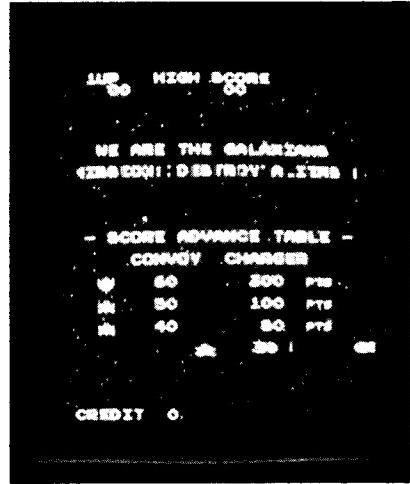
Figures 21 and 22 illustrate symptoms of a bad RAM 3 (IC2101 at 4F and 5F). This problem is probably the most common one you will come across. It can be described as "Breaking Up" of all movement in the rack and Galaxip. Figure 21 best shows what happens when IC5F is bad. Note the wrong letters and the small line next to the moving alien (to the right of the "30"). Figure 22 shows the "Breaking Up" of video. This usually points to IC4F, however, both IC2101's can cause either symptom.

Fig. 21 Typical symptom of a bad RAM 3.

Other symptoms of a bad RAM 3 include, parts of aliens missing, distorted aliens after warm up, flickering aliens, distorted letters, distortion on explosion and "BAD RAM 3" on screen. If these RAMS are in sockets and any of these symptoms appear, replace the RAMS one at a time until it is cleared up. If it proves not to be a bad RAM and the motion is still breaking up, use the video probe in the following manner:

- 1) Place probe on the outputs of the IC74LS273 located at 2M.
- 2) Push reset button and wait for screen to clear.
- 3) Observe the motion and watch for any inconsistency of motion.
- 4) When inconsistency of motion is found, check the input for the same inconsistency.
- 5) If the input is OK, replace the IC74LS273.
- 6) If the input is bad, replace the corresponding IC74LS283 at 4N or 5N according to the schematic.

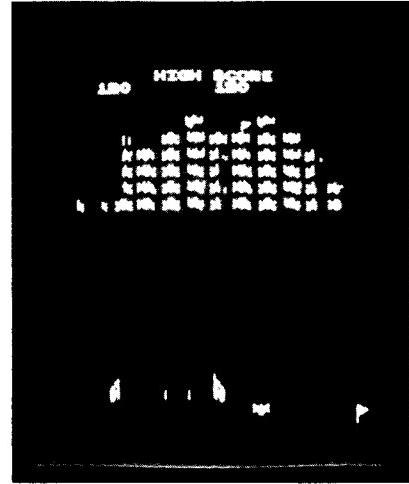
Fig. 22 Typical symptom of a bad RAM 3.

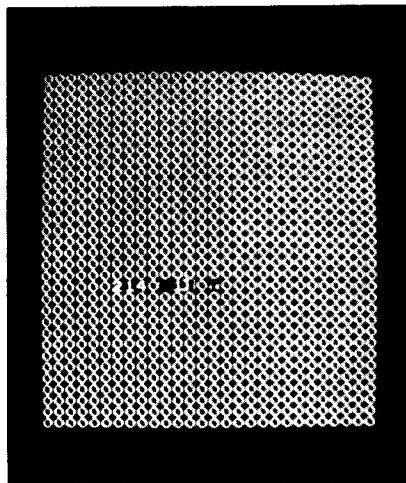
Figure 23 is an extreme case of bad RAM 2 ie missing pin 13 at IC 3F. Usually the board will just read, "BAD RAM 2" on the screen. If this is the case, replace IC2114's at 3F and 3H, or 9B & 5J.

Figure 24 shows a rare case of no sync. Proceed as follows:

Fig. 23 Bad RAM 2

Fig. 24 No SYNC

- 1) Follow the line back from R65 to pin 6 of IC6H for breaks.
- 2) If none, clean contacts on board with a stiff pen eraser.
If that doesn't work, replace IC6H.

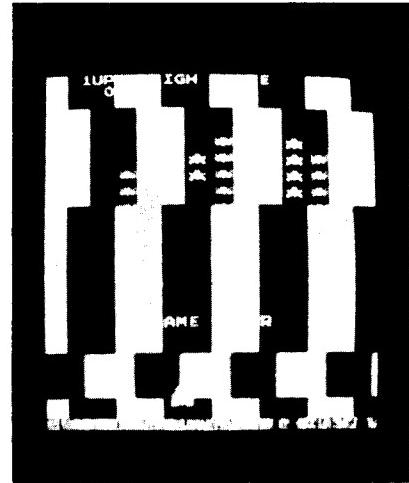
Figure 25 shows an input to the RAMS at 3F and 3H. It looks like fig. 9 except for the Address visible along the bottom. It is an output from a 74LS157 multiplexer located at 3E. This IC "adds" the outputs from the 74LS273 at 2M and CPU ADDRESS to supply "VRA" Address to the IC2114 RAMS at 3F and 3H.

Fig. 25 Showing output data from IC5N and CPU address being multiplexed at pin 7 IC2F.
